Installation of Existing Lift Systems for the Handicapped on Light Rail Vehicles

Prepared by
The Budd Company

May 1985
Final Report

1. Report No. UMTA-MA-06-0153-85-2		2. Government Accession No.		3. Recipient's Catalog No.	
4. Title and Subtitle INSTALLATION OF EXISTING LIFT SYSTEMS FOR THE HANDICAPPED ON LIGHT RAIL VEHICLES				5. Report Date May 1985

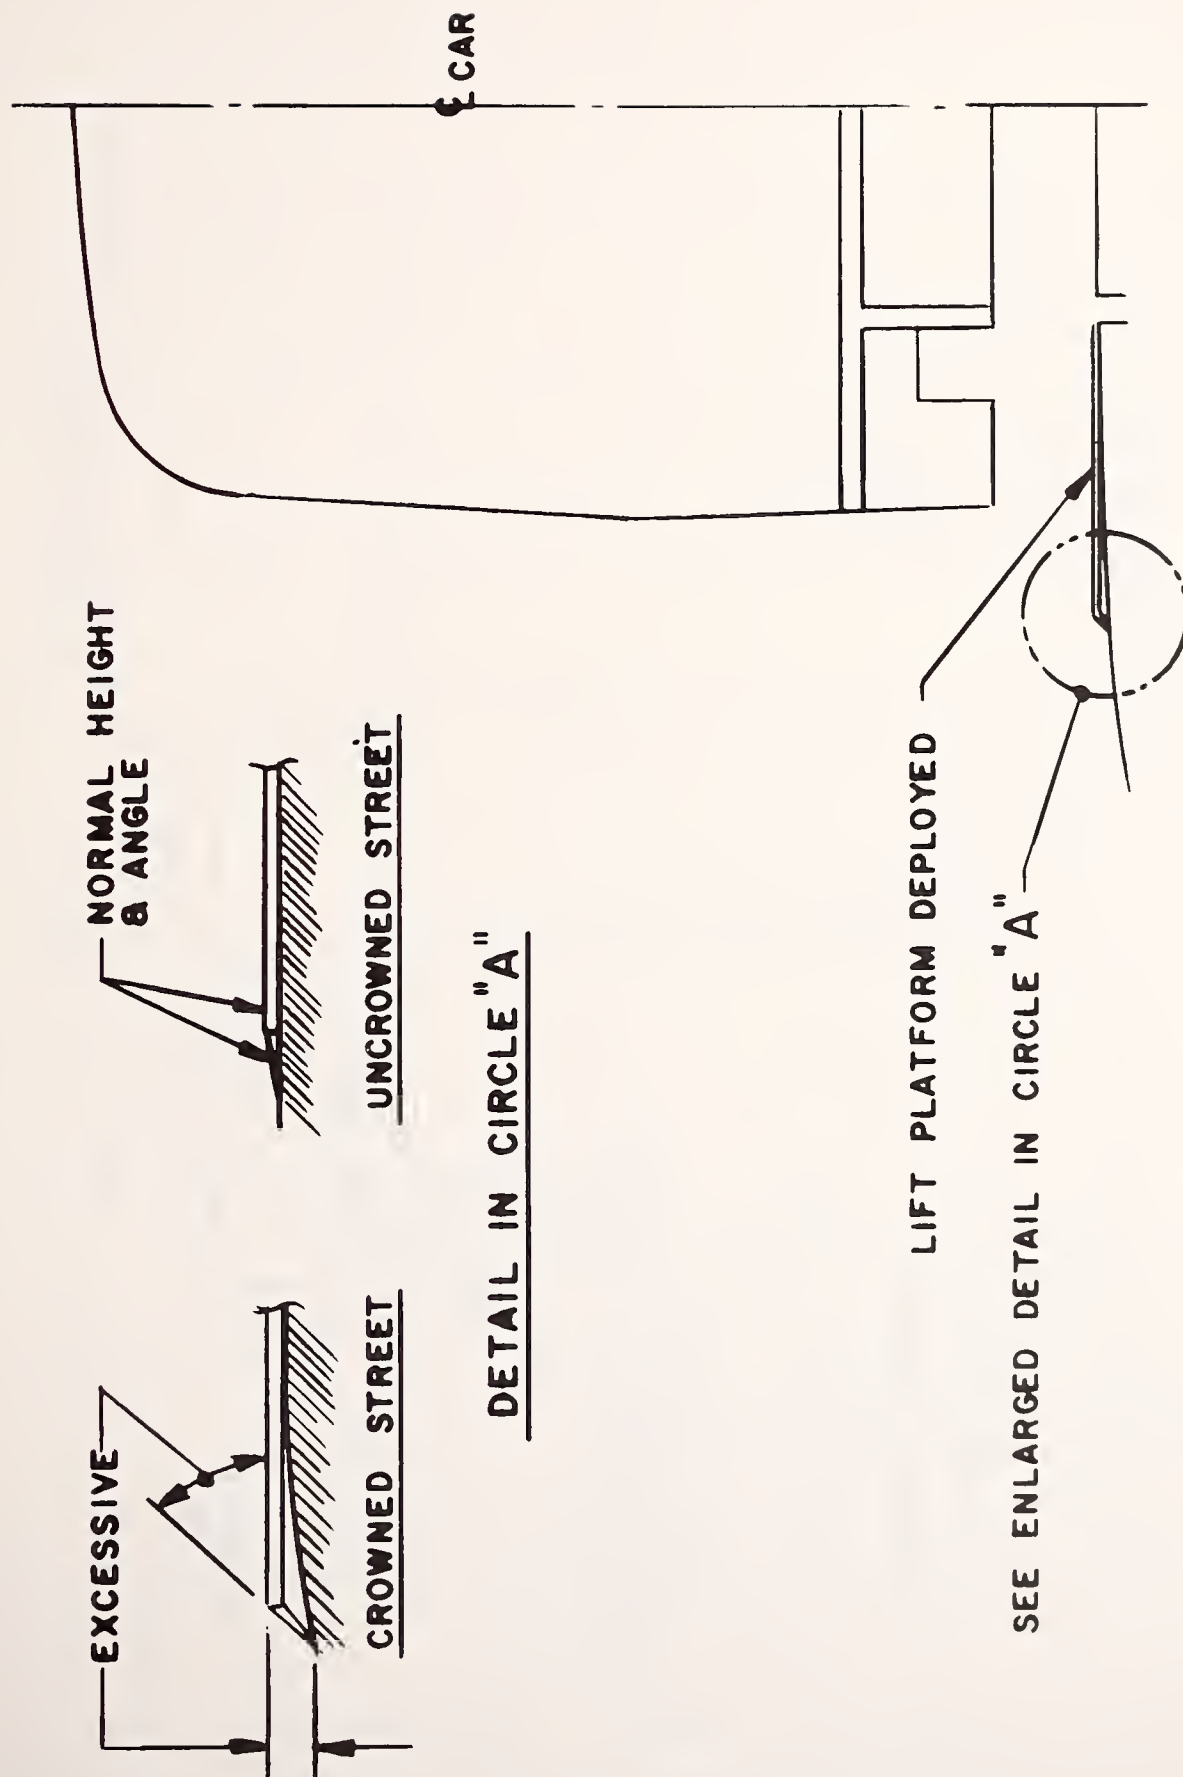
FIGURE 3-1. IN-STREET BOARDING

One major concern in the lift installation is the projection of the deployed platform beyond the vehicle side. This projection creates two types of problems - the crowned street/lift ramp angle interaction and island platform clearance and are illustrated in Figures 3-1 and 3-2 respectively. Figure 3-1 shows that a person attempting to wheel onto the lift will face increasing difficulty as the platform projects further out on the crowned street because the effective ramp angle for entry increases as a function of the degree of street crowning and

extension of the platform. Even in those instances when the lift platform can "relax" somewhat to conform to the road surface conditions the overall effect on the boarding passenger is one of increased difficulty with the increased platform angle. Another way to improve the ramp angle problem is to have a thin lift platform which automatically reduces the entry angle, but this can only be done to the point where it does not affect other criteria.

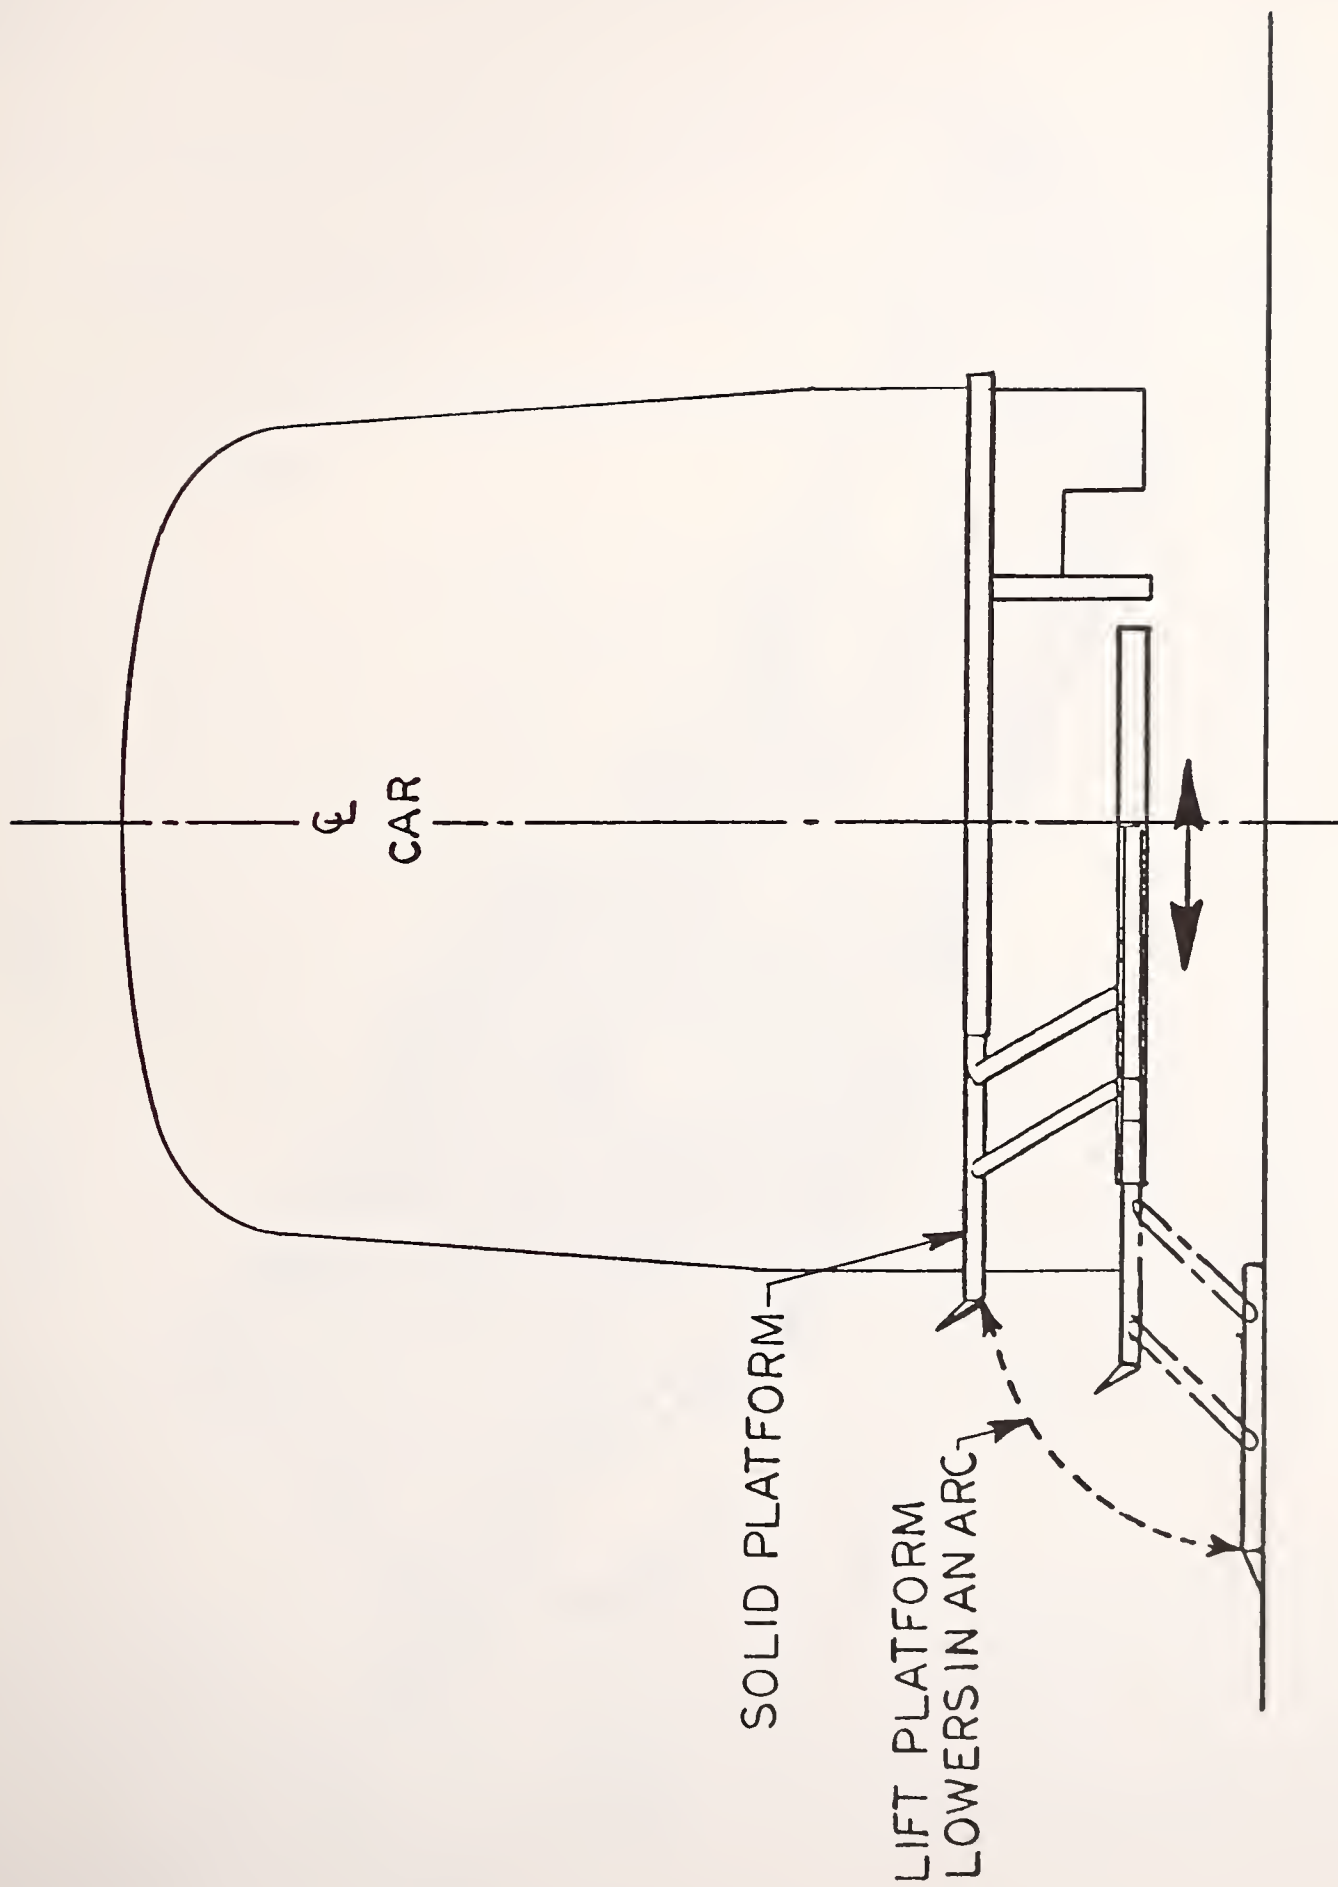
FIGURE 3-6. LIFT-U CROSS SECTION

The operating principles of the Lift-U are shown in Figures 3-6 and 3-7. The front position of the platform is the lower step in the lift stowed position. To use the lift, the platform is extended outward from the channels. Then, it can be raised and lowered on the four side arms that constitute a pair of parallelogram linkages. In the stowed position, the lift is not subject to drifting outward, because it is effectively locked by the screw-thread that

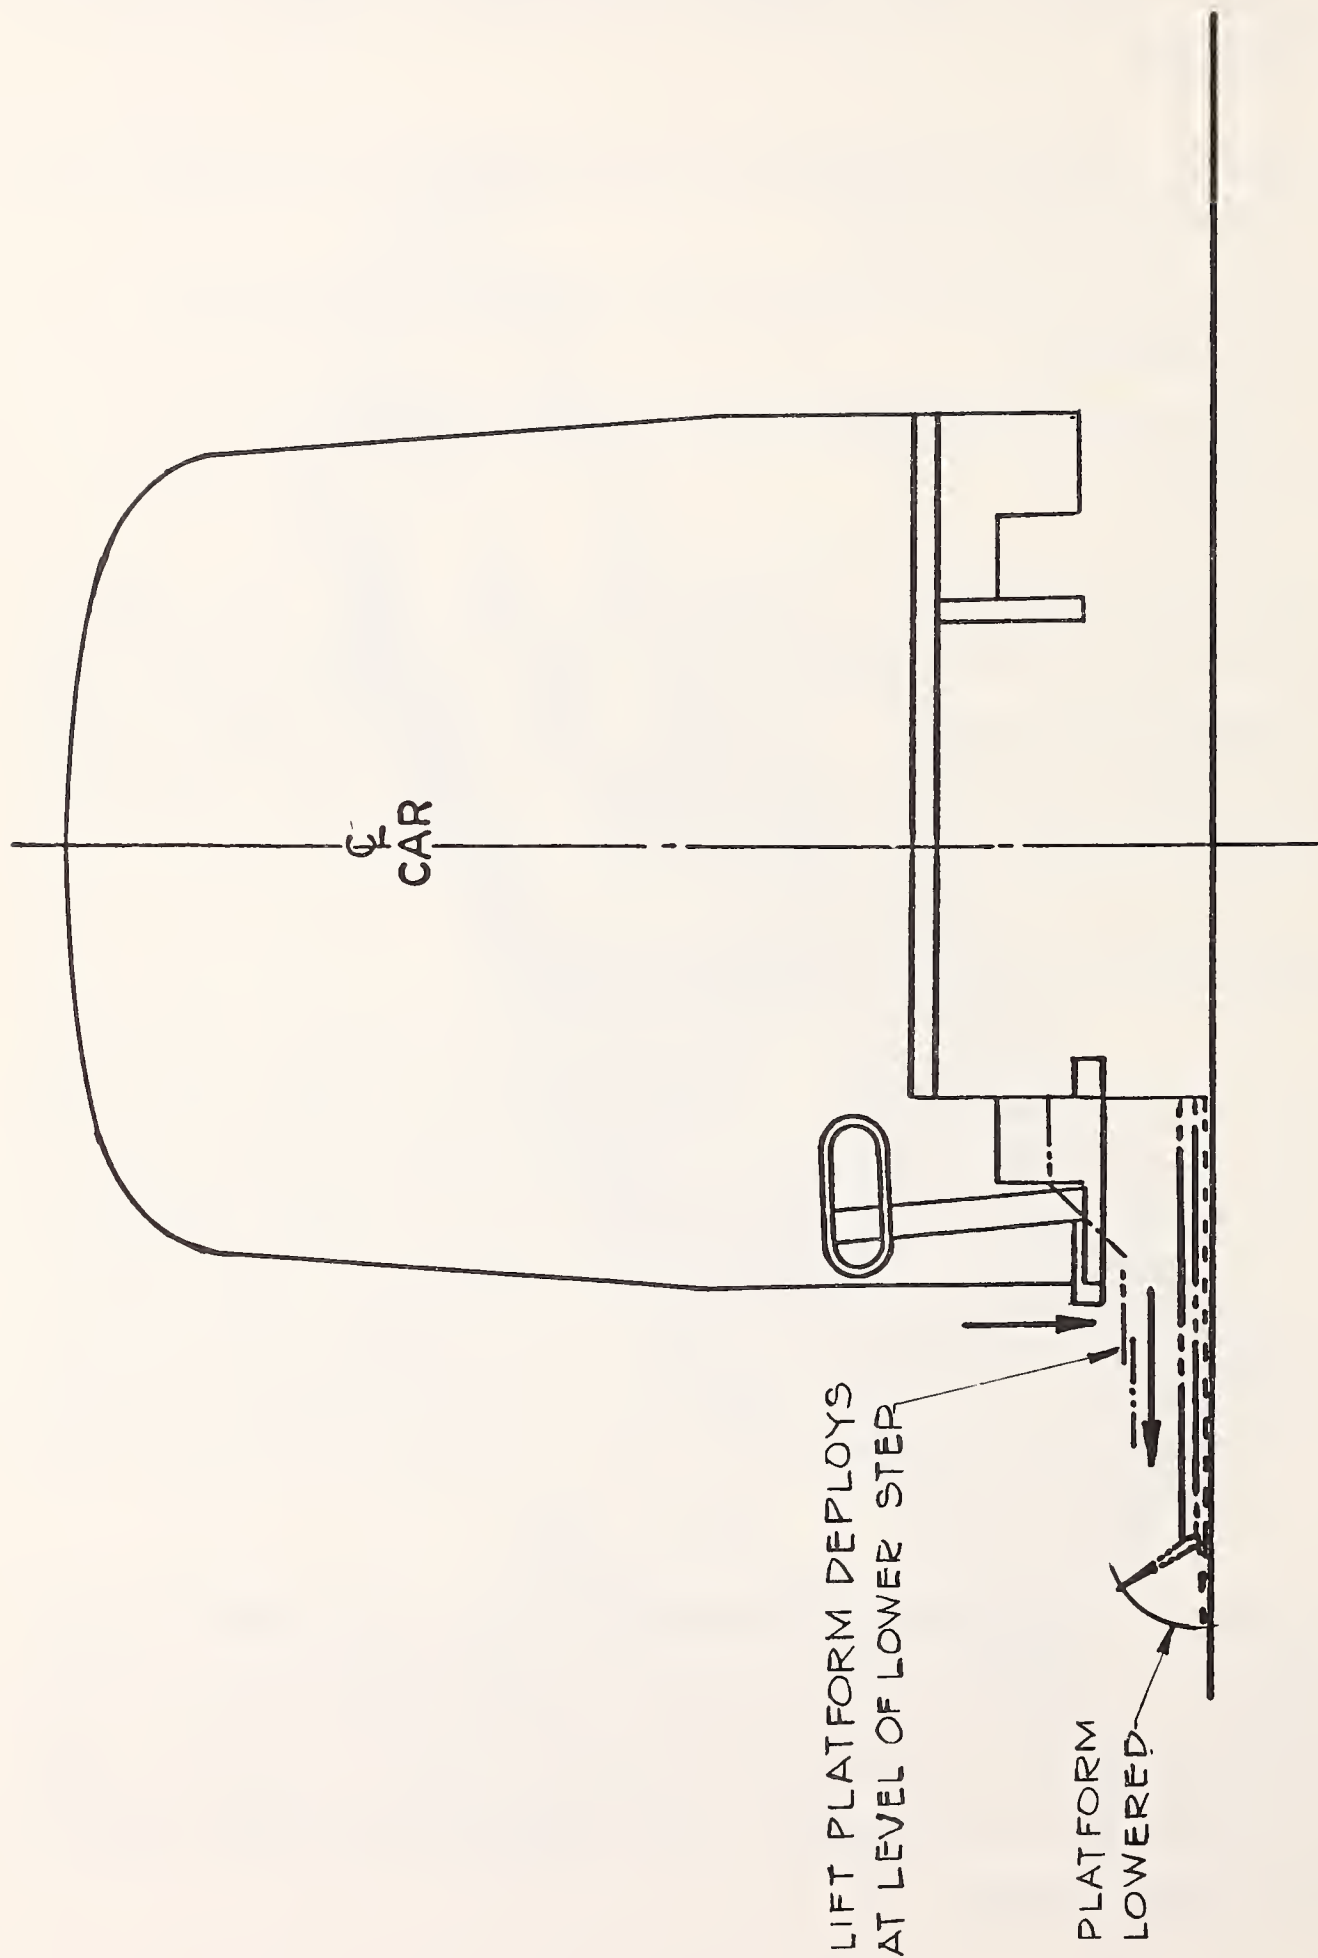
FIGURE 3-8. TDT CROSS SECTION

A drawing of the lift is shown in Figures 3-8 and 3-9. The controls consist of four switches, a two-position switch to extend or stow the platform, a three-position switch to raise or lower the platform; a three-position switch to deploy or retract the platform; and a three-position switch to raise or lower the safety gate at the outboard end of the platform. The three-position switches return to the off position when released.

The TDT lift is an elevator type which raises and lowers with no lateral movement and, therefore, the projection beyond the side of the vehicle does not present a problem. The lift platform contains hydraulic cylinders and other mechanisms for deploying the platform which results in a thick and relatively rigid platform, characteristics which are not desirable in an LRV lift installation. All the elevator type lifts can be installed on the Boeing LRV without major structural changes. The TDT lift, however, has a projection back under the car frame which could cause problems on other vehicle installations (see Figure 3-8).

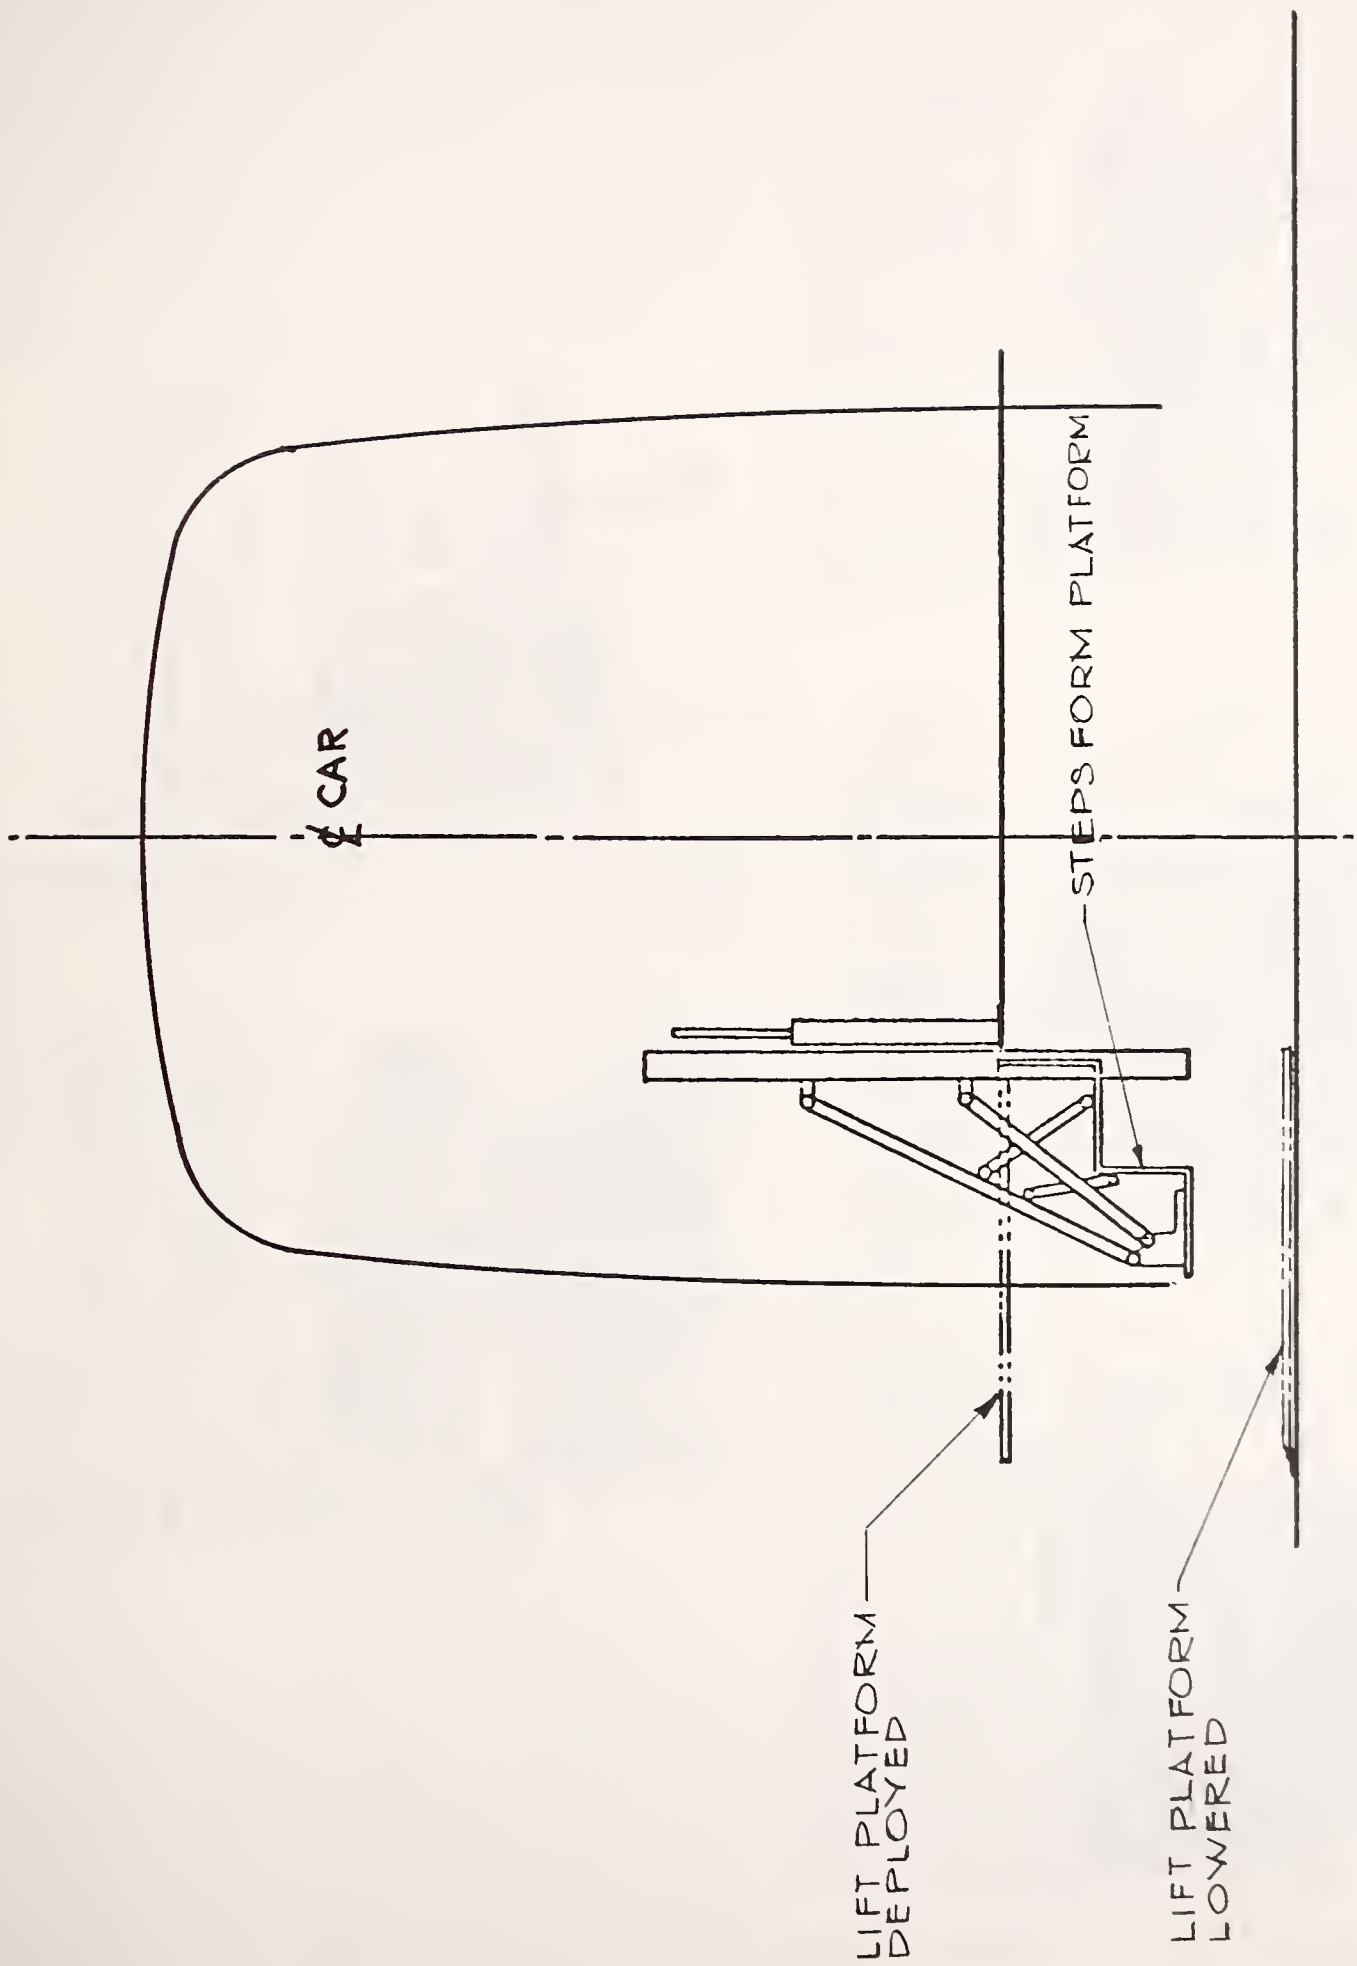
FIGURE 3-10. TRANSILIFT "X" SECTION

The Vapor Travelift forms the treads and risers of the bottom two steps in the stowed position. Hydraulic cylinders located in towers on both sides of the platform control the operation of the lift. One pair of cylinders form the platform. The other pair of cylinders raises and lowers the platform vertically

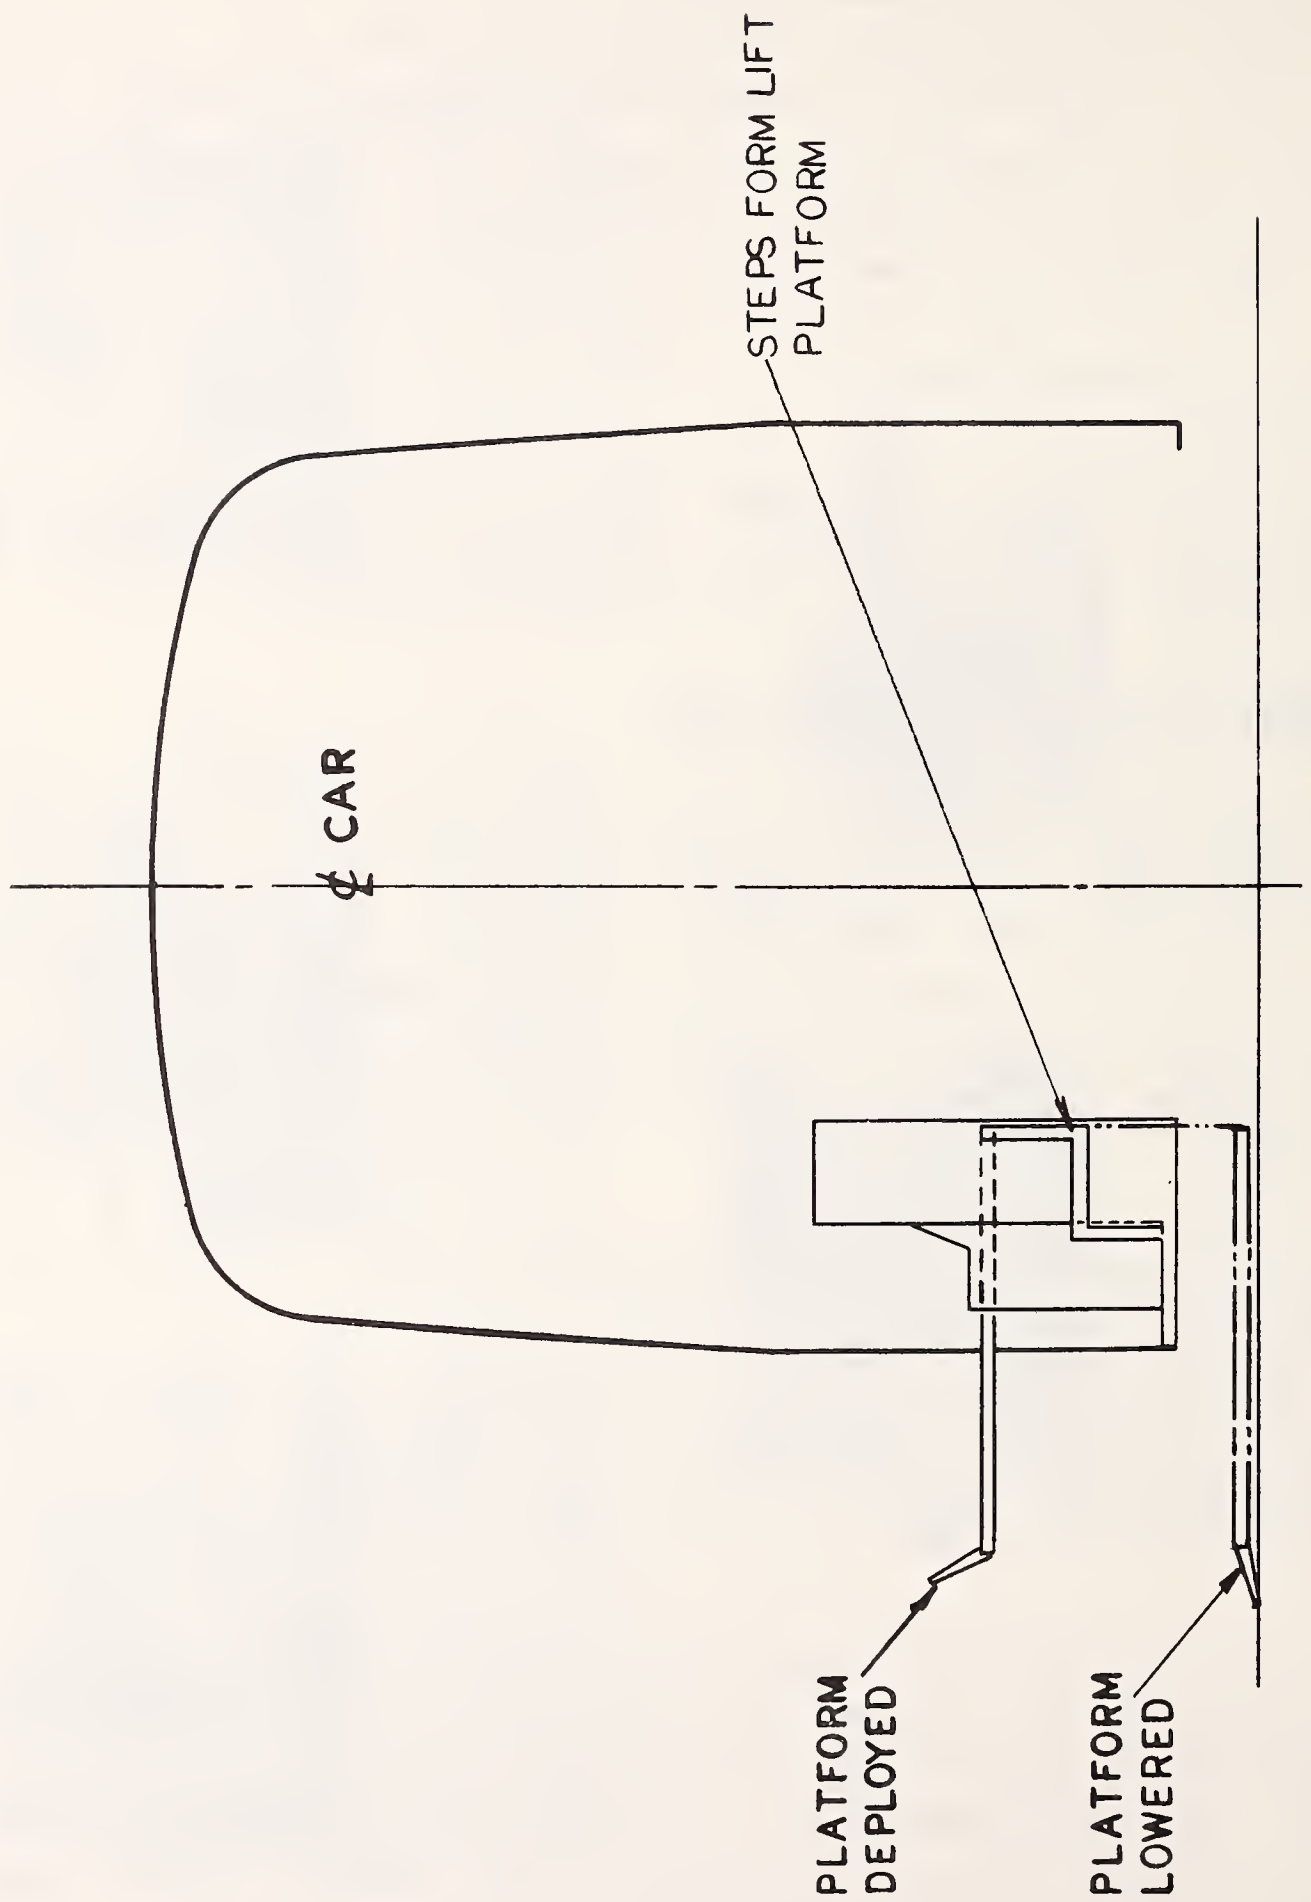
FIGURE 3-12. VAPOR TRAVELIFT

using a scissors mechanism as shown in Figures 3-12 and 3-13. The lift has two sensitive edges (airwave sensors). The sensor on the outboard edge of the ramp stops the lift if an obstruction is contacted as the platform is extended. The second sensor is on the underside of the platform at the outboard edge, to stop the descent of the lift if an object is encountered or when the lift is on the ground. Because the lift is powered down, it has the capability of lifting the vehicle if the second sensor fails to contact the ground before some other portion of the platform touches.

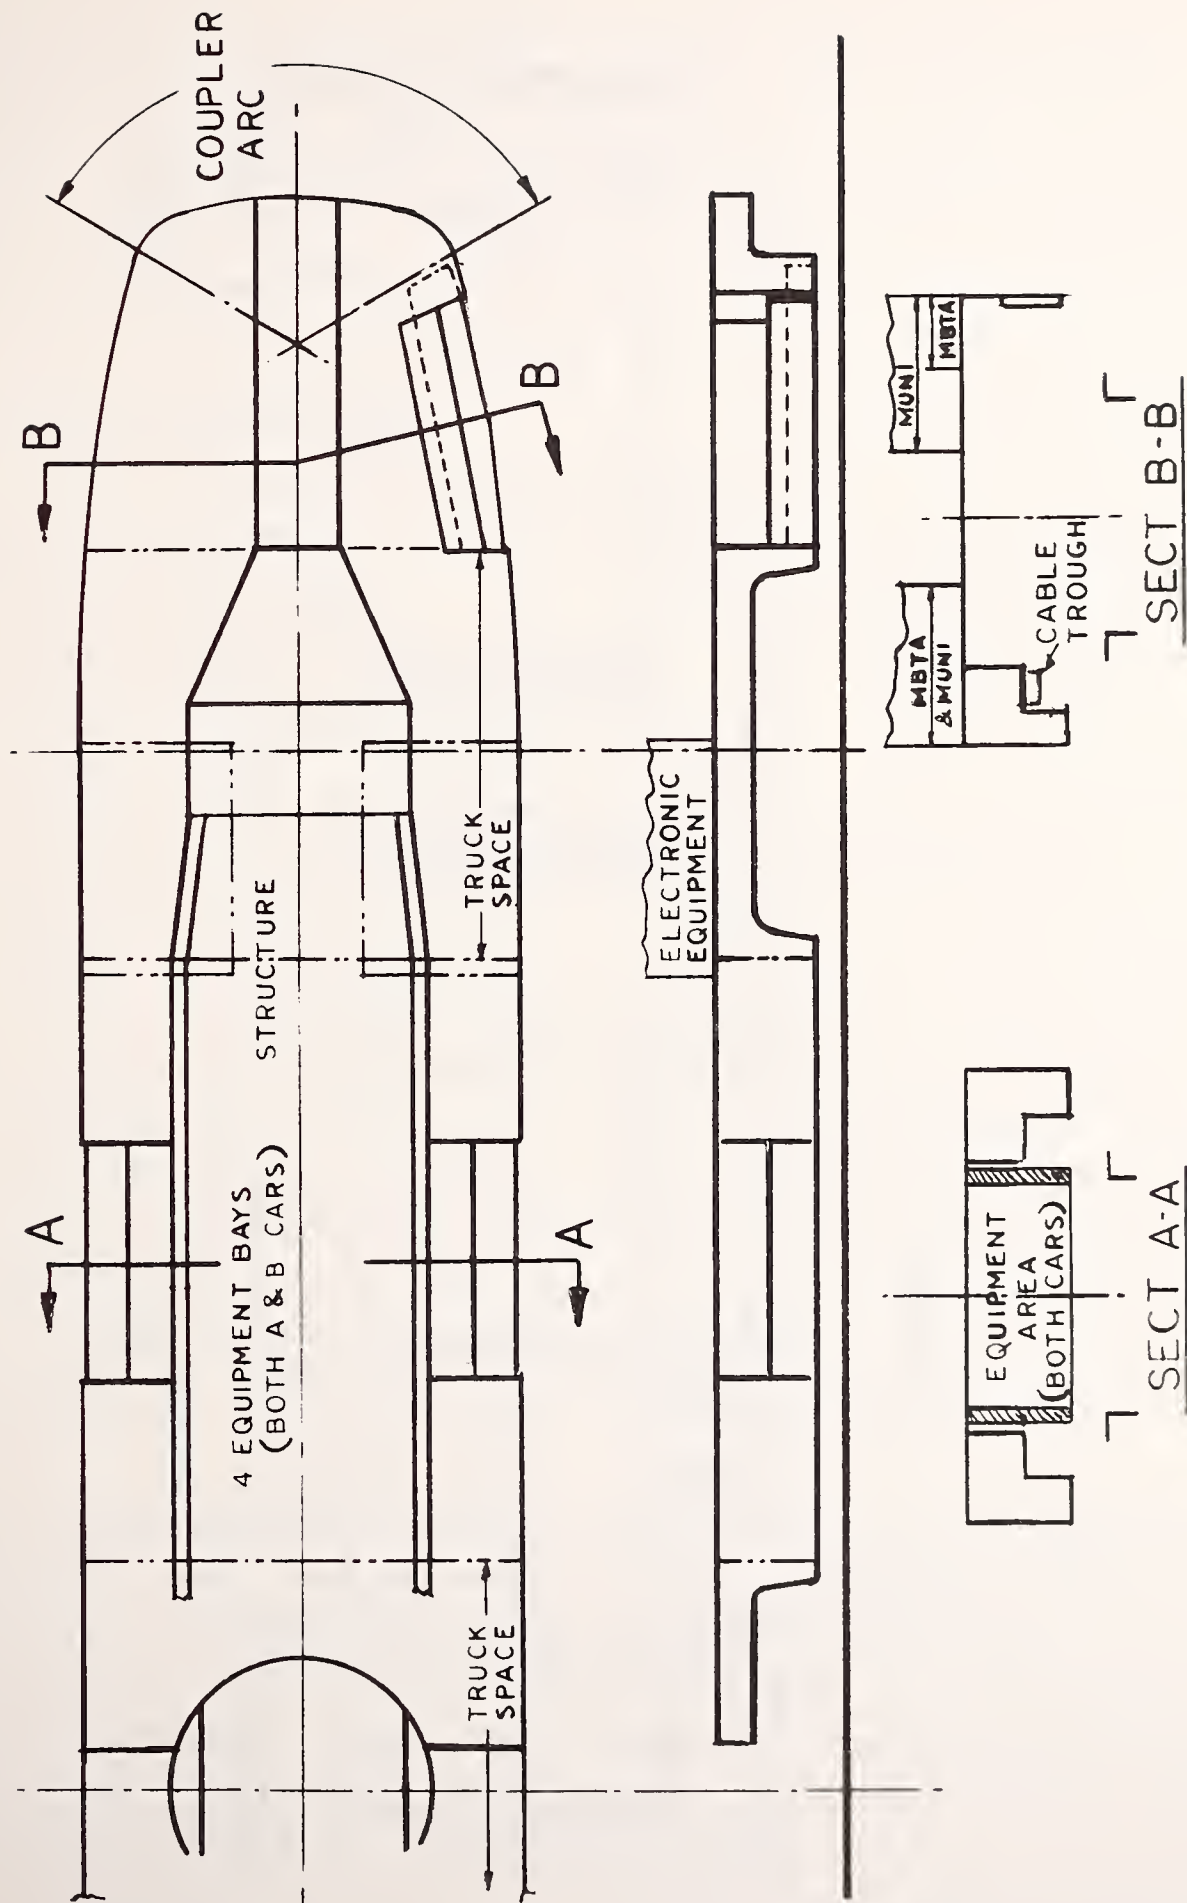
FIGURE 3-14. BOEING LRV FRAME STRUCTURE AND EQUIPMENT SPACES

Half-scale drawings of the doorway areas for the Boeing and Breda vehicles and of the selected lifts were prepared in order to allow for the evaluation of the impact of various lift installations. It was found that the Boeing LRV front stepwell depth (toward the centerline of the car) could be increased significantly without frame modifications to reduce the lift projection from the vehicle because the frame is narrowed as it approaches the drawhead. The Boeing LRV center stepwells, in contrast, cannot be deepened without undertaking frame modifications. Figure 3-14 shows the Boeing frame arrangement and the location of equipment spaces for both the MUNI and the MBTA configurations.

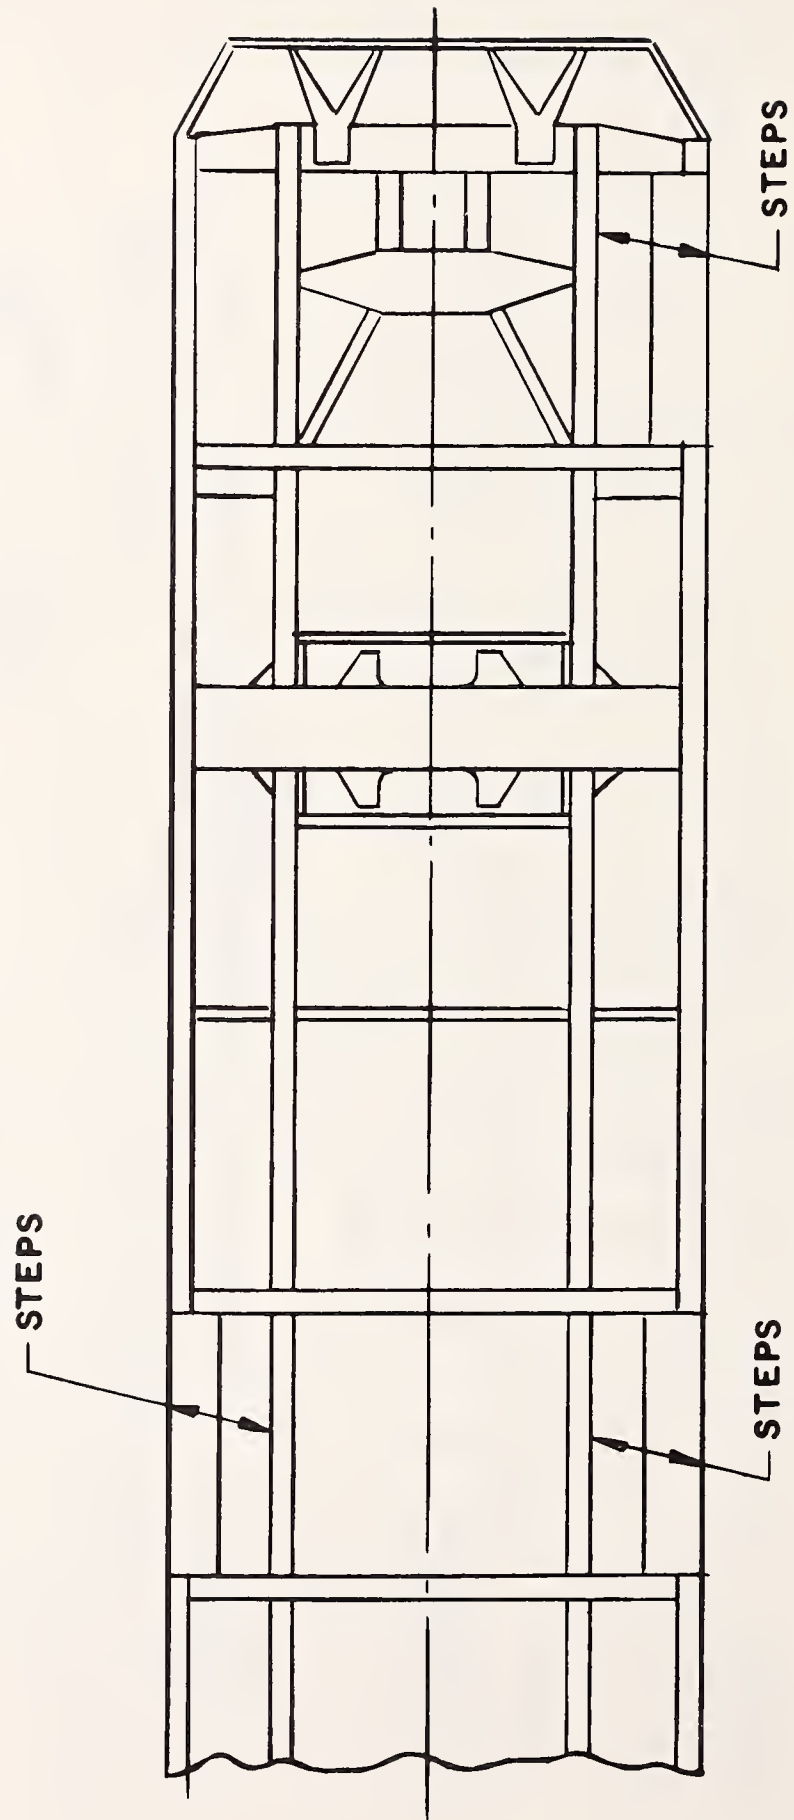
FIGURE 3-15. BRED A FRAME STRUCTURE

On the Breda LRVs, the front doorways at each end of the vehicle are parallel with the side of the car. Counting the two center doorways, the Breda LRV has six identical doorways per car. The center sills of the Breda cars are parallel along the whole length of the car and, as a result, lift installation conditions are the same for any of the six doorways. Like the center doorways on the Boeing cars, the Breda stepwell depth at any doorway cannot be increased without incurring frame modifications. Figure 3-15 shows the Breda frame structure.

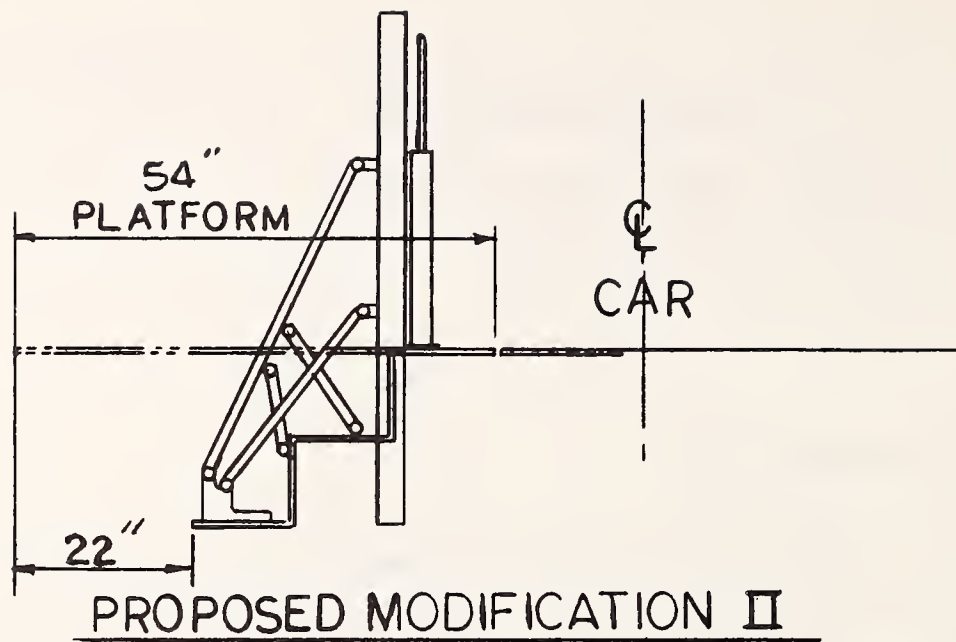
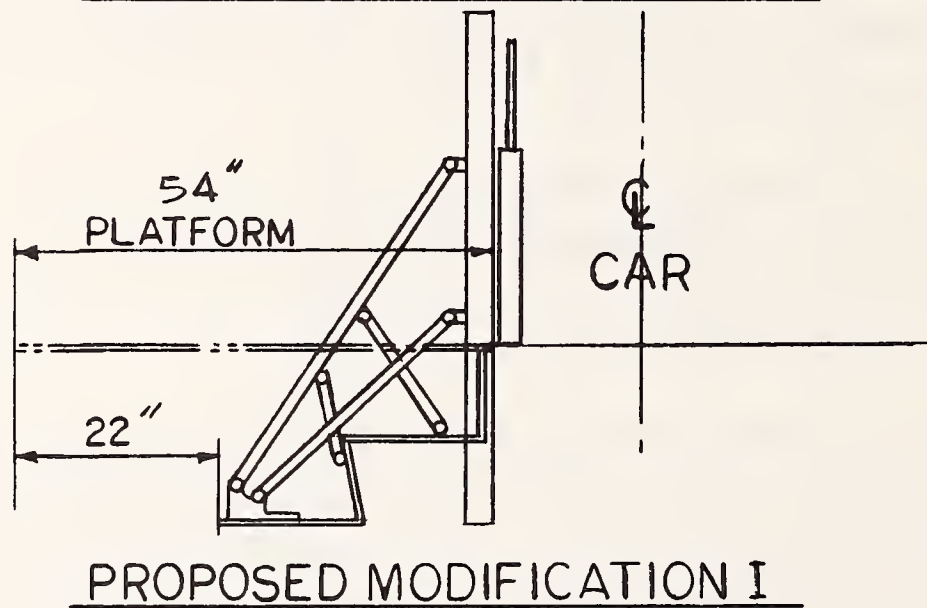
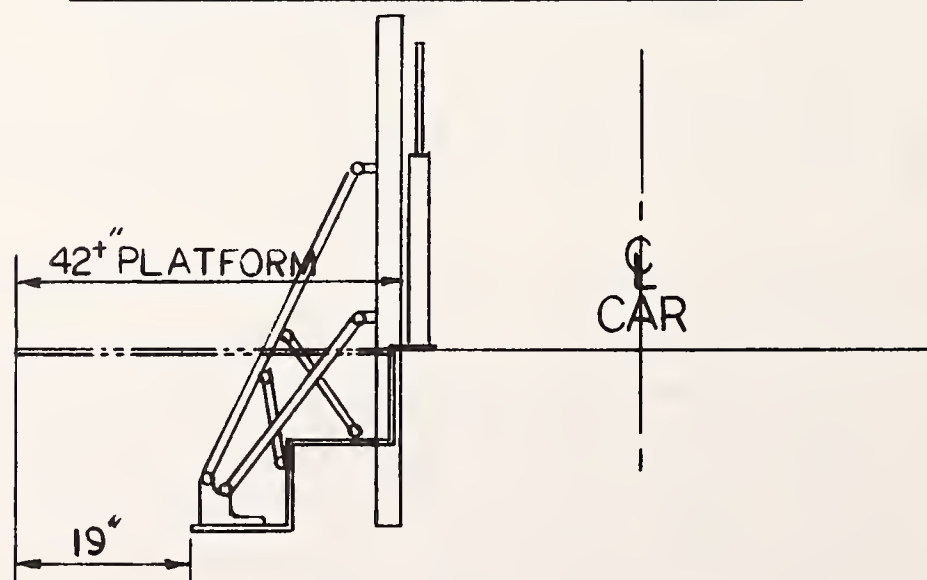
FIGURE 3-16. EXISTING ARRANGEMENT TRANSILIFT CROSS SECTION

The existing TransiLift tread and riser dimensions corresponded closely to the Boeing step dimensions and would fit into the present stepwells, but the platform was only about 42 inches long. Consequently, the TransiLift was studied further to identify modifications which would help in improving its overall acceptability. Figure 3-16 shows the progression of the modifications considered based upon the existing TransiLift arrangement. Both Modifications 1 and 2 were directed toward increasing the lift platform length.

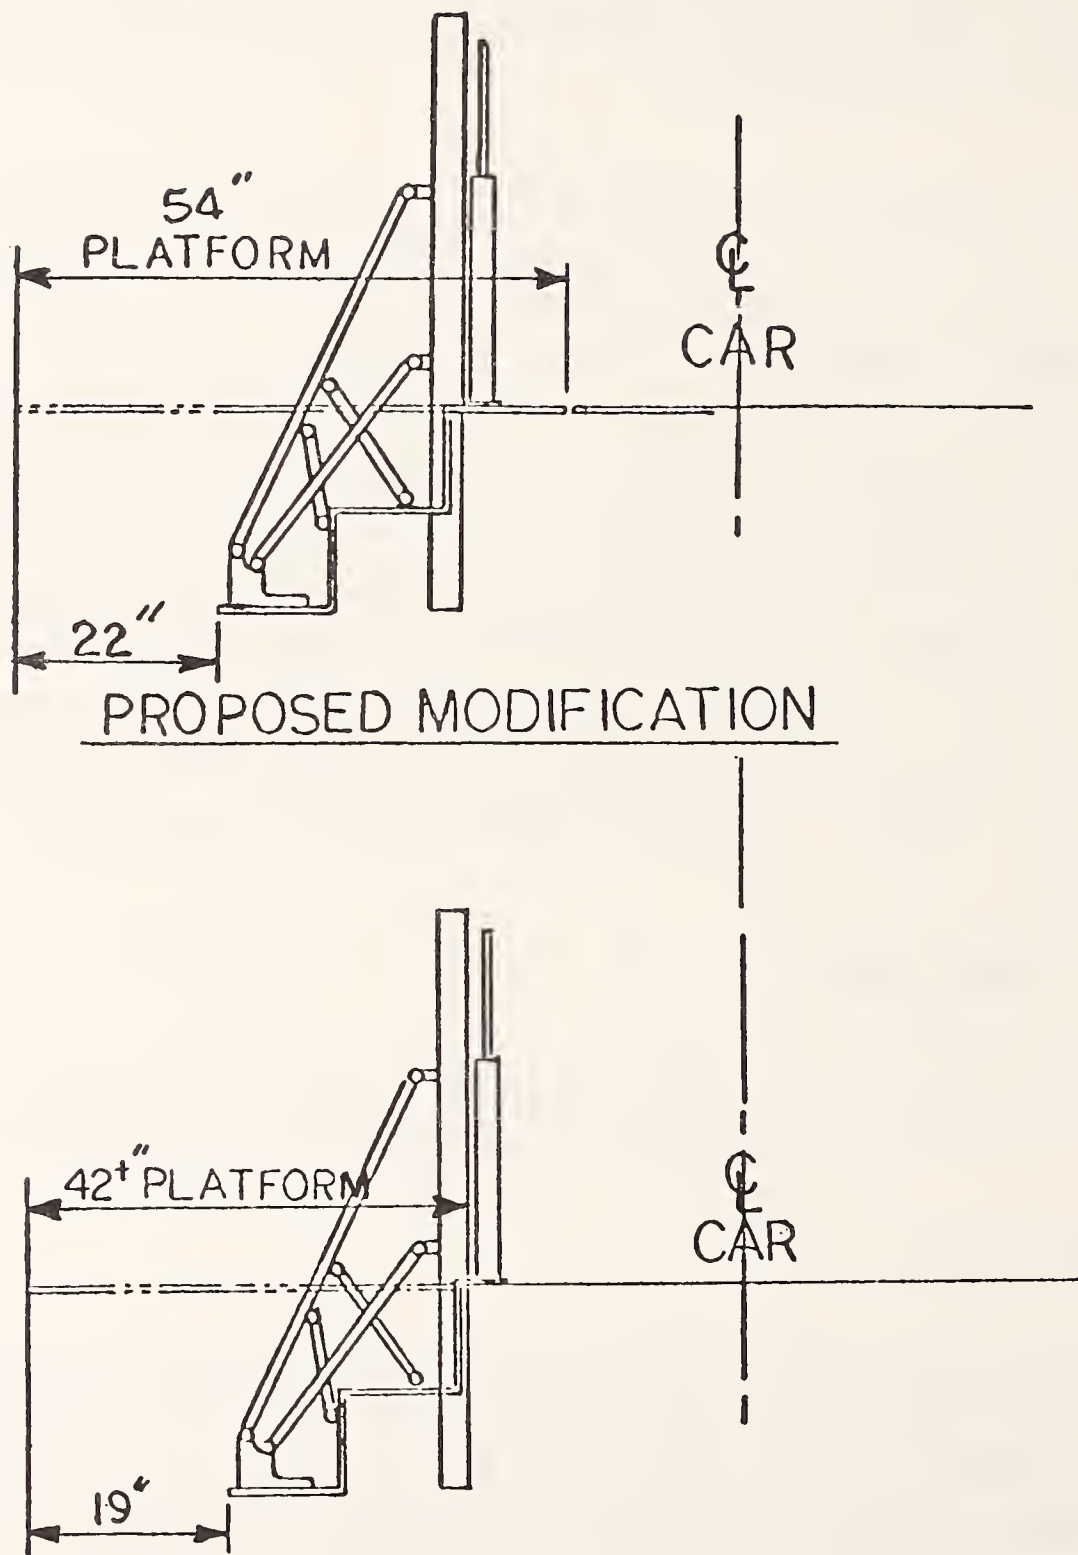
FIGURE 4-1. EXISTING ARRANGEMENT TRANSILIFT CROSS SECTION

The maximum feasible modification to the front doorway was determined to be removal of the front steps from wall-to-wall, and partial removal of the immediately adjacent floor. A structural analysis of the existing and modified vehicle doorway was made to compare the stresses for normal loads and for collisions at the right front corner. As expected, the stresses for normal loads, including the additional weight of the lift, are not significantly increased.

The first test of the vehicle structure involved measuring the distortion that occurred at the doorway when the steps were removed. It was found that virtually no movement occurred, demonstrating that the steps did not contribute to carrying any static structural loads. For collision loads, the lift structure itself effectively replaces the integral steps, because the lift steps are able to transfer compression loads as easily as the integral steps. It is necessary to accept some slight structural deformation to close the clearances at the side of the steps before they become effective in compression.

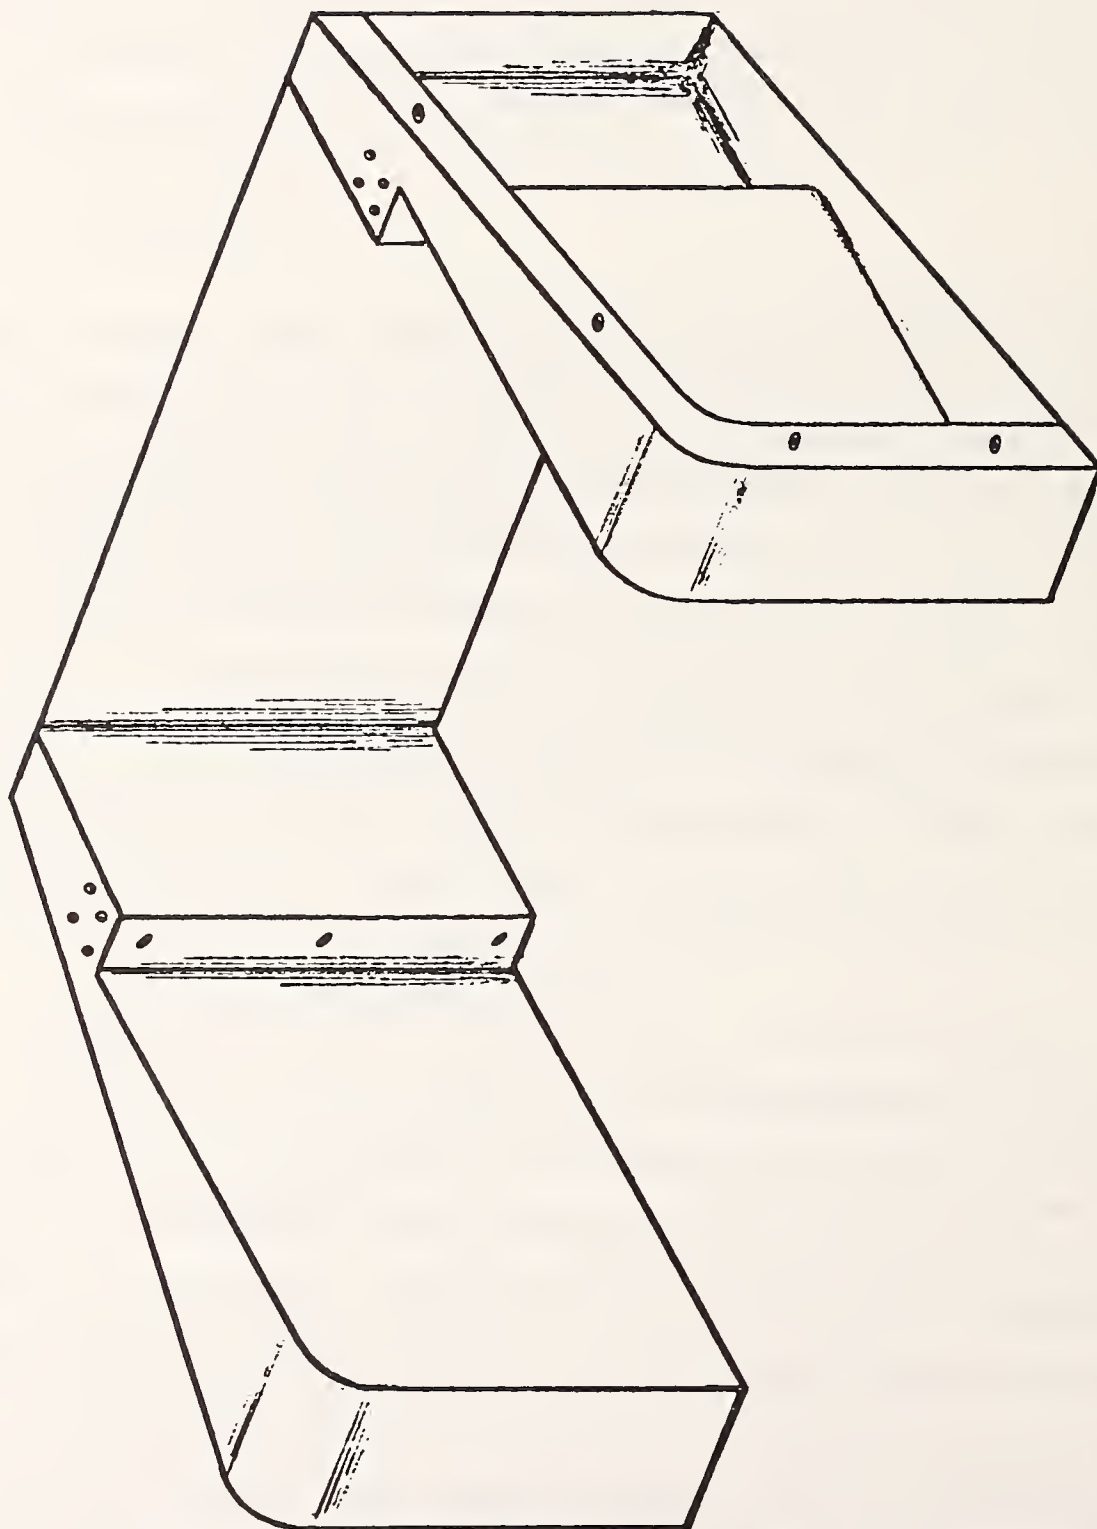
FIGURE 4-2. LIFT POD STRUCTURE

The pod structure is a sheet metal assembly that serves as the frame onto which lift components are mounted, such as the lift towers and the safety plate at the back of the lift. The pod is mounted as a single unit into the vehicle. Figure 4-2 shows the pod unit without equipment mounted on it. The pod has
